## IS CONCRETE SPALLING DANGEROUS?

Author: LAU Yeo Shin | 30 January, 2020

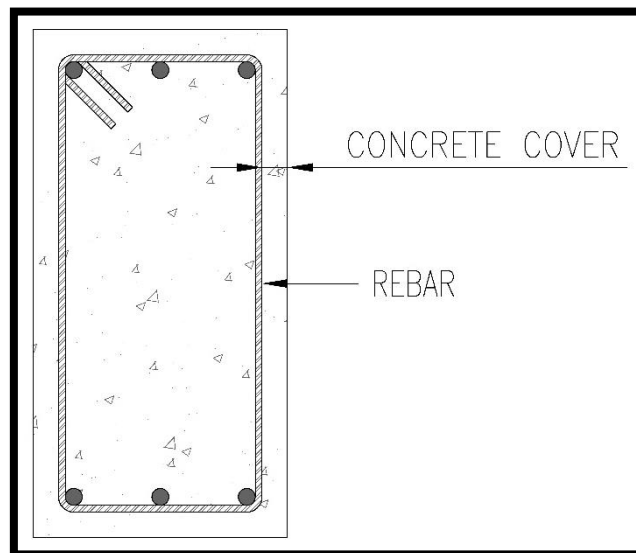
*Figure 1: Concrete Cover & Rebar*

Concrete spalling refers to the common structural defect where surface concrete (“concrete cover”) falls off locally and exposes the steel reinforcement bar (“rebar”) underneath. Concrete spalling is easily visible and does not require a state-of-the-art instrument for detection. It usually happens years into service of the completed buildings in which property owners and management bodies have to take their initiatives to regularly inspect, discover, and rectify the defect.

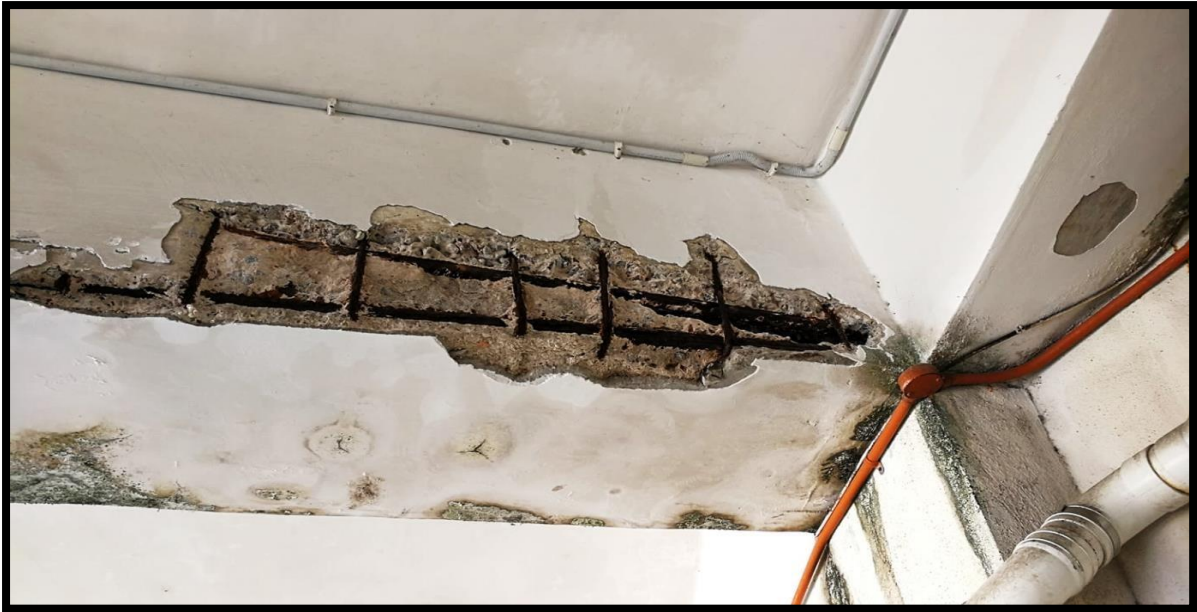
*Figure 2: Concrete Spalling On a Beam Due To Moisture Intrusion*

Concrete spalling not only damages the aesthetical appearance of the building but also affects the structure performance and stability in the long run if immediate remedy is not applied. Concrete is a mixture of cement, aggregates, and water which hardens over time, which is strong in compression (“push”) while weak in tension (“pull”). This means concrete falls apart relatively easily when being pulled, approximately at a magnitude of 10% of its capacity under “push” pressure. This weakness in concrete is overcome by providing rebar which has good tensile resistance in structural concrete members to take up the tension force in the member. Spalled concrete exposes the rebar underneath to atmospheric moisture as well as direct contact with water on some other occasions. This promotes rebar rusting where rebar diameter and hence its tensile capacity reduces over time, up to a point where such rebar completely breaks or is too badly damaged and is structurally inadequate for the designated structural member. In such scenario, structure failure is just a ticking bomb which is of no surprise to an engineer.

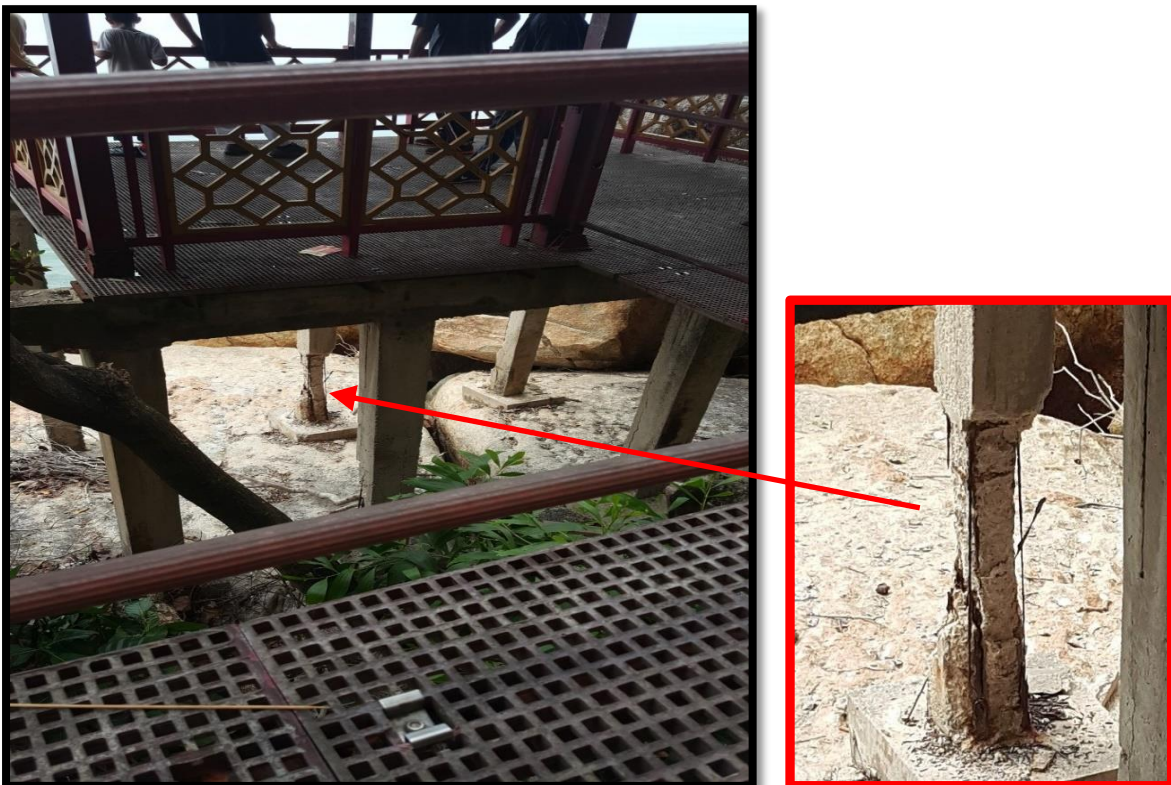
*Figure 3: Badly Damaged Column with Considerably Total Loss of Rebar at a Coastal Building*

Albeit rusting is a long process, the property owner or management body shall not underestimate the consequence of concrete spalling and leave the defect unattended for a long time. Structure collapse due to rebar corrosion is not a new topic in the industry. The recent structural collapse of Algo Center Mall in Canada and Genoa Bridge in Italy should be our lessons in closely monitoring the structural integrity of reinforced concrete structures. Spalled concrete shall be rectified not only by mere patching, but with cause identified and rectified. Regular inspection is necessary to monitor the existence of further rust development of the repaired concrete spalling, and also to identify any other new structural defects that appear in the building that need proper rectification.
