SAFE TO OCCUPY BURNT BUILDINGS?

Author: LAU Yeo Shin | 23 September, 2019

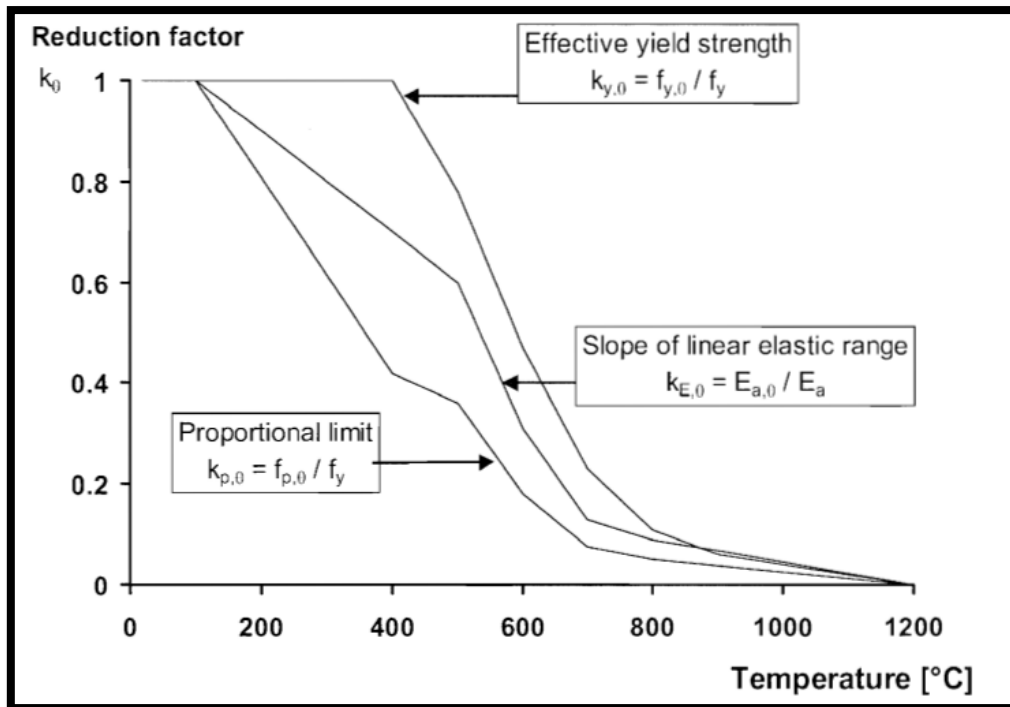
Figure 1: Reduction factor for effective yield strength, proportional limit and Young's Modulus at elevated temperature (abstracted from BS EN 1993-1-2:2005)

As for structural steel, Eurocode 3 Part 1-2 has specified a constant yield strength up to 400 degrees Celsius and decreases rapidly afterward with 22% reduction at 500 degrees Celsius, 53% reduction at 600 degrees Celsius and 77% reduction at 700 degrees Celsius as illustrated in the figure shown below. Yield strength reduction at elevated temperature promotes earlier occurrence of steel member buckling which is otherwise prevented at room temperature. Besides, reduced yield strength also forced steel members to undergo unrecoverable plastic deformation (unless by heat straightening in limited applications done by experienced personnel) which is why extraordinary deformation is always observed on steel members after most fire incidents. Various tests can be deployed to determine the extent of fire damage to steel members in combination with visual inspection. In cases and regions where steel exposure to fire is less extreme, reusing the steel members with or without further strengthening could be possible after verifications by an experienced engineer.

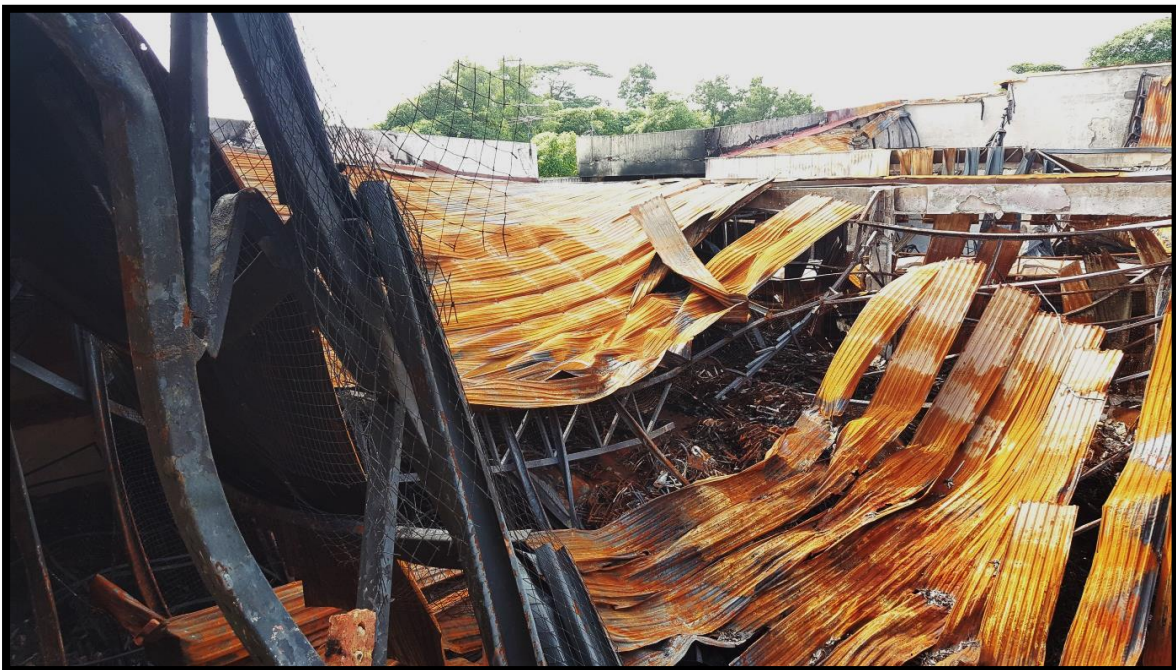
Figure 2: Steel roof truss damage under elevated temperature

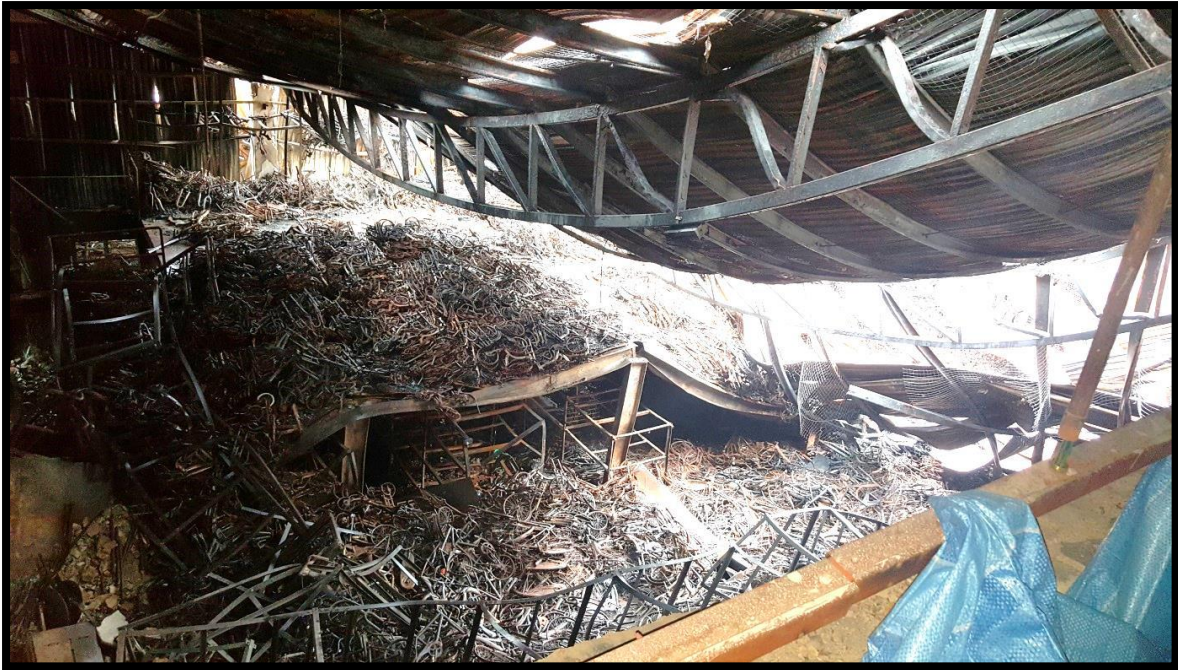
Figure 3: Steel roof truss and platform damage under elevated temperature

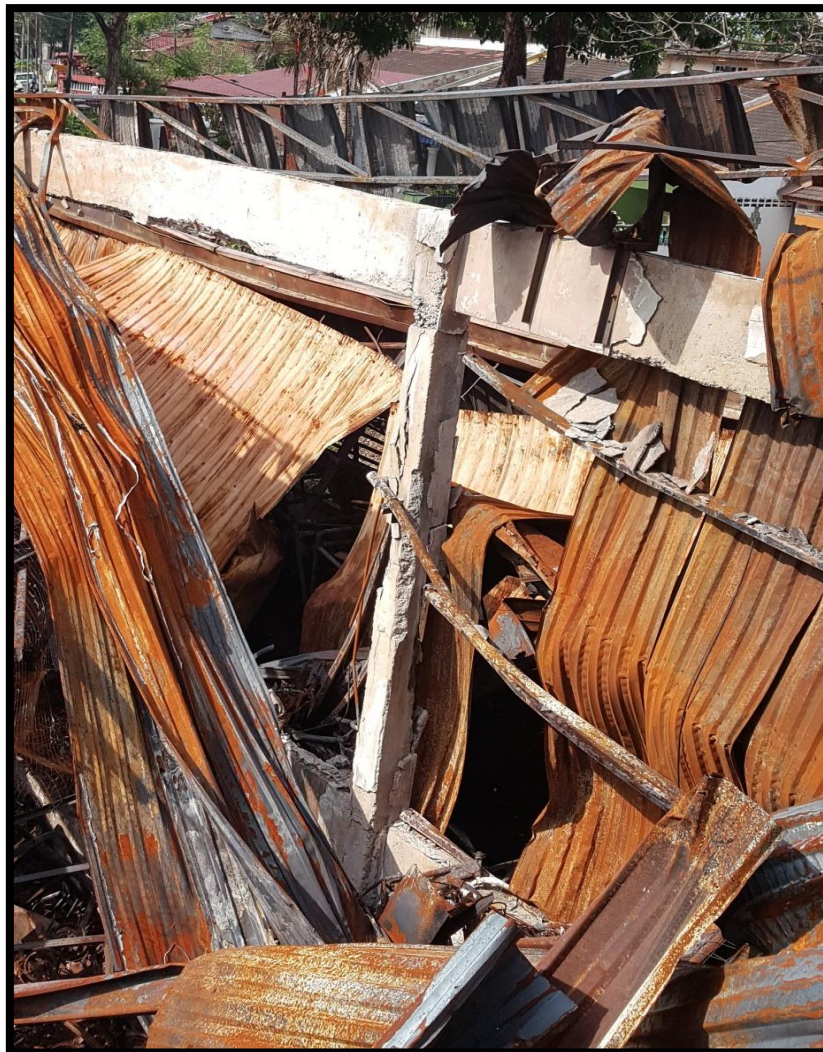
Figure 4: Concrete spalling at column under elevated temperature

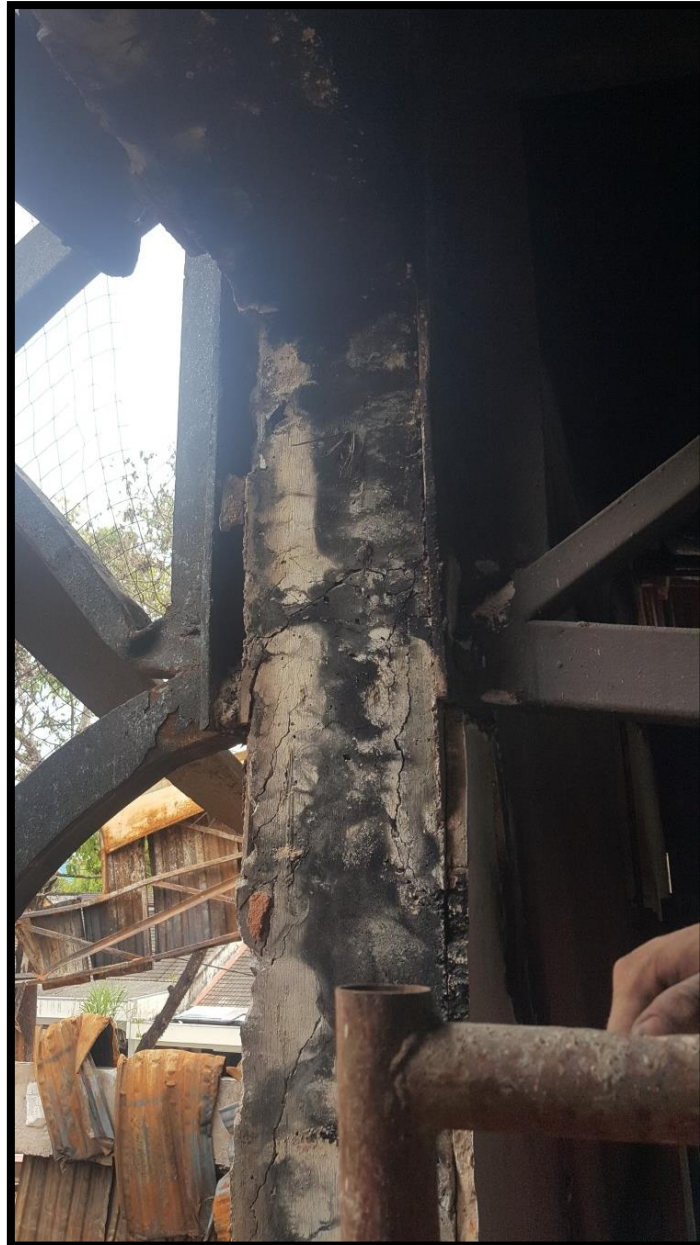
Figure 5: Structural cracks discovered on concrete column after removing party wall for inspection
